Pad printer machine scraping ink is not clean, problem resolve

How should you address the issue when the ink scraping in an ink cup pad printing machine is not clean?

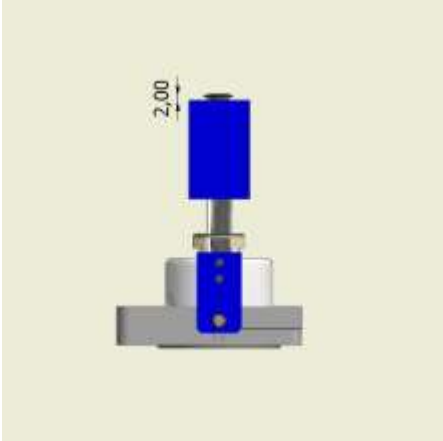
D: Ink Cup holder

(1) Ink cup holder should be horizontal lock, unless external forces are not easy to damage .

(2) At least 2mm when the holder bracket is pressed under the ink cup cover .
